## TWO CASES OF MRI-INDUCED SKIN BURNS

### PRIMERA OPEKLIN NA KOŽI PRI MAGNETNO RESONANČNEM SLIKANJU

**Gašper Podobnik**

Onkološki inštitut Ljubljana, Oddelek za radiologijo, Zaloška cesta 2, 1000 Ljubljana

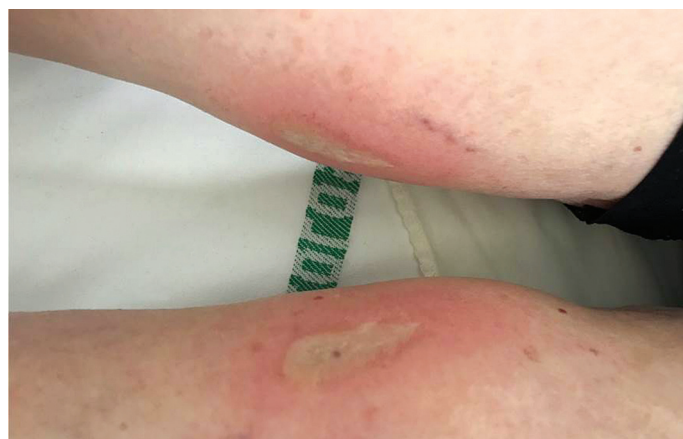
There were no peculiarities during the examination, except at the end the patient complained about the increased temperature between her thighs. At the junction of her thighs, there was a red area on the skin and a white blister appeared after 15 minutes (Image 1). The female patient was referred to a surgeon who cared for the wound and provided her written instructions on how to care for the burn.

Image 1: Photograph of the medial side of the thigh with burns on both sides

We could prevent this by using insulation between the thighs, such as foam pads, at least 1 cm thick, which would prevent the creation of a closed conduction loop.
